**Watershed Restoration Program
Overview and Level 1
Fish Habitat Assessment**

**Unnamed Tributary of Mohun Creek
(locally known as Coho Creek)**

prepared for the
**Campbell River
Fish and Wildlife Association**

By
Monica Stewardson

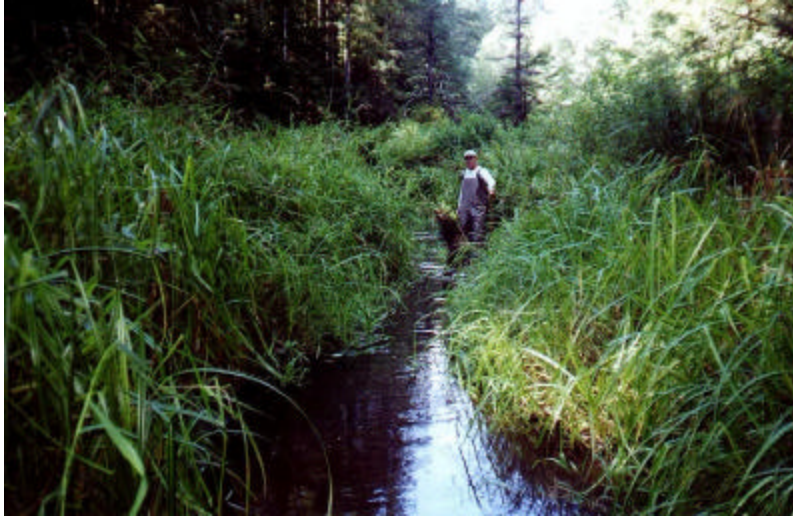
Site 1 was completed in Reach 2 of Coho Creek. The downstream end of the reach is marked by the double culvert crossing on the Iron River main. Immediately upstream of that crossing the channel has ponded for approximately 15m. Upstream of the pond, the low gradient, 4.5 m wide channel flows through a grassy wetland bordered by a mixed (coniferous and deciduous) young forest. (Photo 1). Approximately 240 m upstream of the double culvert, an old railway grade trestle runs through the channel for 18 m. At least 114 pieces of trestle are present in that section and many of them still standing (Photo 2). At this time, the trestle is not a barrier to the upstream migration of fish.

Photo 1. A downstream view taken in Site 1, from 200 m downstream of the upper reach break.

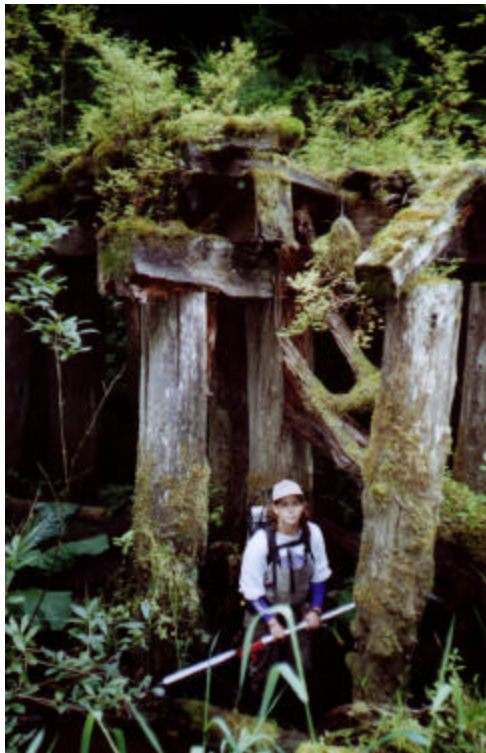
Photo 2. A downstream view of the railway trestle, most of which is still standing in the channel in Site 1.

Table 5 contains a summary of the assessed habitat values for this reach. With the exception of the trestle debris, large woody debris is scarce in this reach. It appears there is little or no natural recruitment of large woody debris into the channel. This is

likely due to the age of the surrounding forest (61 - 80 years old). Second growth forest, such as that bordering this section, provides a higher proportion of smaller diameter coniferous and deciduous trees than old growth forest. This type of debris degrades more quickly than old growth debris, and therefore has less value as large woody debris (Cederholm et al, in Slaney, P.A. and Zaldokas, D., 1997).

The railway trestle crossing in this section of Coho Creek is a major concern at this time. The large amount of debris present in the 18 m section of stream impacted by the crossing could potentially become a barrier to the upstream migration of fish as it continues to collapse into the channel. This is particularly critical as all the potential spawning areas in this system are located upstream of this crossing. If coho salmon are returning to spawn in Coho Creek, blocking access to the spawning areas would be extremely detrimental. It is recommended that the trestle be dismantled and removed from the channel. This would be a fairly simple exercise, and would involve cutting the debris into suitable size pieces using a chainsaw and removing them by hand from the stream. Care would have to be taken to ensure a minimum disruption to the channel as the work was conducted.

3. Remove railway trestle debris in Reach 2 of Coho Creek, and redistribute with other large woody debris materials throughout reach to improve large woody debris abundance and distribution in this reach. (requires further project planning)
4. Complete improvements to the Iron River Main culvert crossing.
5. Attempt to obtain the missing information for Tributary 4. Further planning for restoration in this stream can be completed, if necessary once this information is available.

A railway trestle crossing is mostly still standing in Reach 2 of Coho Creek. At this time the structure is having little impact on the fish habitat. If the structure were to collapse into the channel, it could form a debris jam that will block fish migration and/or effect the flow of the channel. Removing this structure and using the debris for large woody debris placement is highly recommended.

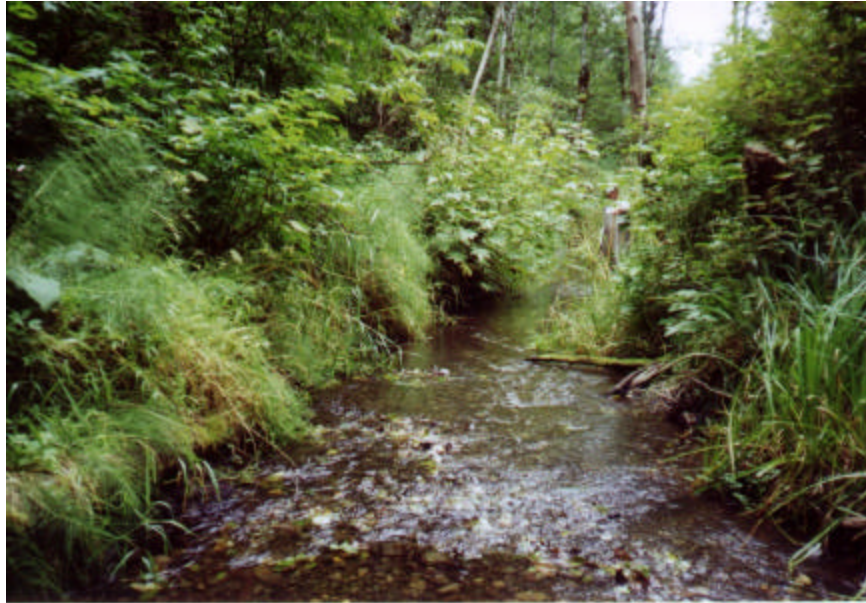
Photo 3. A downstream view into the spawning habitat present in Site 2, taken from the break between Reaches 8 and 9.

In general, overhead cover was good due to the large amount of vegetation overhanging the channel (Table 6). The amount of large woody debris and boulder cover was low in this reach. The abundant pools in this reach were long, deep lateral scour pools associated with the channel bends.

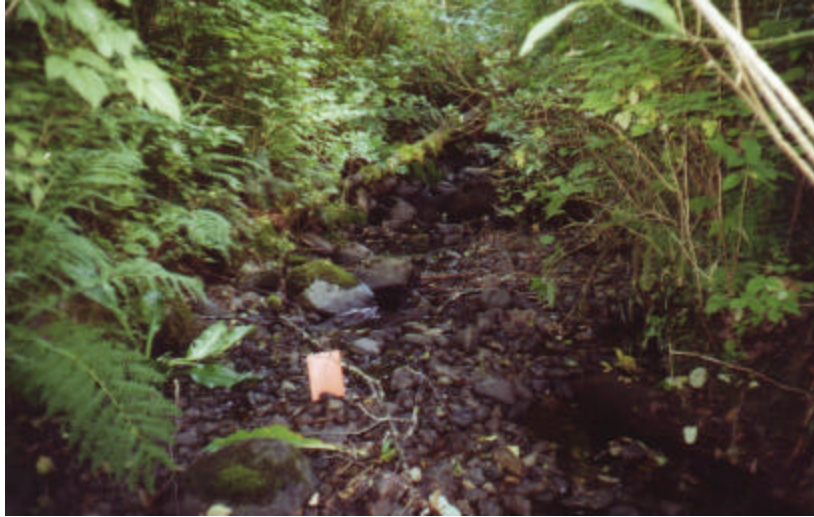
Trestle debris is concentrated in a 16 m section of this reach. The "fair" rating for large woody debris presence for this reach is due to trees falling into the channel from the adjacent deciduous forest (41 - 80 years old) on the v-shaped side slopes. Again, the quality of the natural large woody debris present is low because it consists of smaller and more quickly degraded trees.

Photo 4. An upstream view from the downstream end of Site 3. Note the lack of pool areas and low water flow.

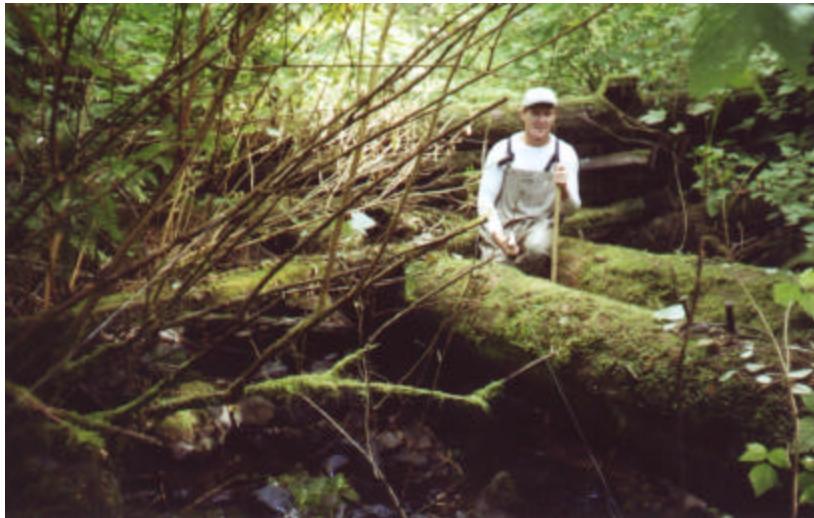
The trestle debris itself does not appear to be blocking fish passage at this time, as the channel flows underneath the debris jam. However, sediment deposits upstream of the jam are causing the flow to be intermittent above the debris, and may be affecting fish access to the wetland area in Reach 5 of this stream.

Photo 5. An upstream view at the downstream end of the collapsed trestle. The channel flows underneath the debris.

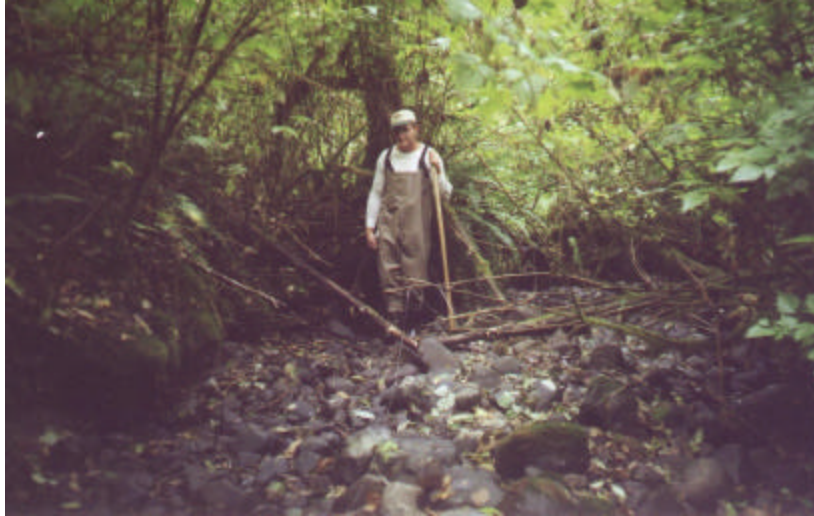
Habitat disturbance in this site was evident by the lack of habitat complexity, similar to that found in Site 3. Other disturbance indicators observed included eroded banks, elevated mid-channel bars and the orientation of much of the large woody debris parallel to the banks. Sediment deposition is responsible for the infilling of possible pool areas in much of the site.

Photo 6. An upstream view of a cascade in Site 4, taken 35 m upstream of the confluence with Coho Creek. There is little water flow at this point.

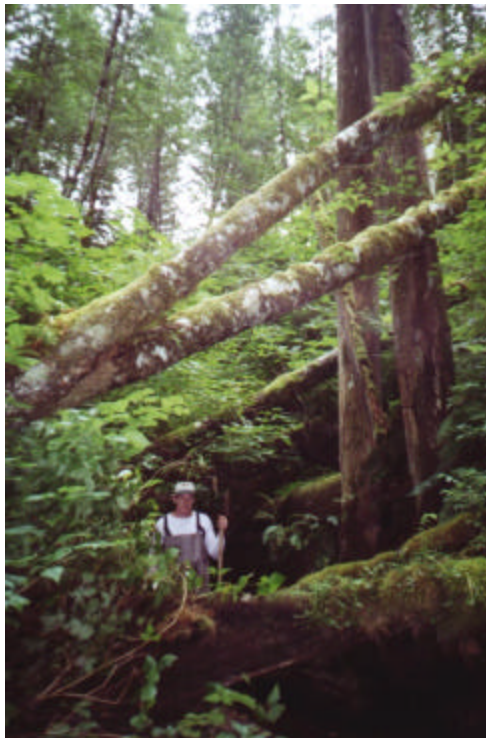
Trestle debris was distributed throughout this reach, downstream of where it had collapsed into the channel (Photo 7). The dispersal of the debris results in an overall ranking of good for the large woody debris presence. As in Site 3, the riparian vegetation consists of a young deciduous forest (41 - 60 years old) on steep side slopes. This suggests that the natural large woody debris amount would be similar to that found in Site 3. Large woody debris is the dominant overhead cover type, with some overhanging vegetation and very little boulder cover.

Access to upstream areas is not blocked by the trestle debris. The low surface flow would have more impact on upstream migration and the survival of rearing juveniles.

Photo 7. An upstream view of the channel where the railway trestle has collapsed.

Recommendations for improving habitat in Reach 1 of Tributary 4 includes restoring natural flow patterns and removing and redistributing the railway trestle debris in the channel. Obviously, the trestle debris in the channel is impacting the habitat present, and the recommendations made for Site 3 could apply to this reach as well. A large amount of important information is missing for this stream for the upper section that was not surveyed and for which historical data does not exist. It is suspected that natural flow levels have been altered in this tributary, and possibly the Coho Creek drainage as a whole. Depending on the severity of this action, it could be influencing fish migration patterns and affecting habitat quality in the tributary and Coho Creek mainstem downstream of this point. Therefore, prior to doing any work on this tributary, the current status of the unsurveyed section of this tributary needs to be determined. Once this information is made available, better recommendations can be made regarding potential restoration opportunities.

4. Attempt to obtain the missing information for Tributary 4. Further planning for restoration in this stream can be completed, if necessary once this information is available.
